Leaking Masonry Walls / Leaking Mortar Joints

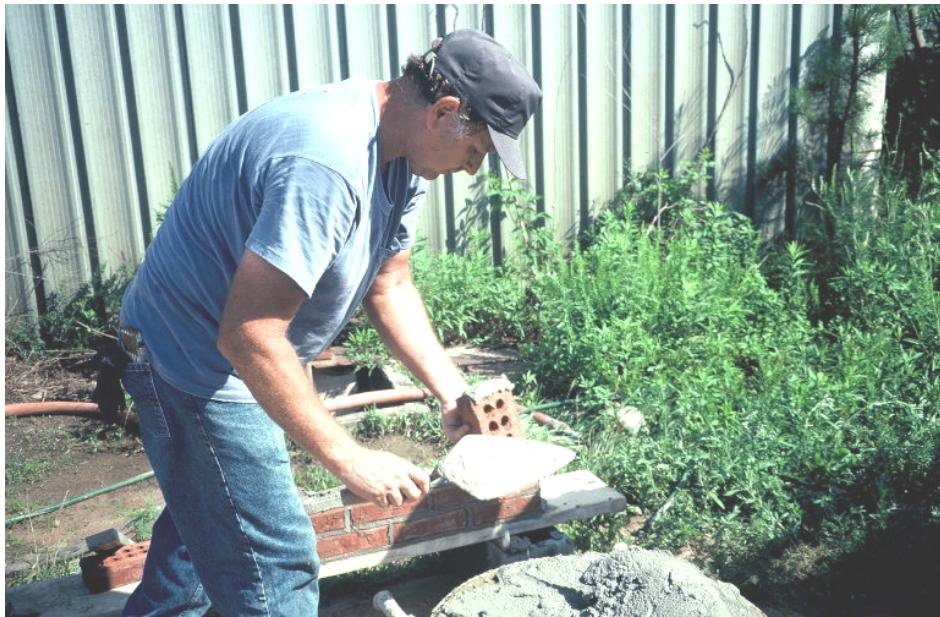
Figure 1: The mason applying mortar to the head of the brick.

A classic, typical example of a non-full brick head joint can be seen below. Figure 1 shows the mason applying mortar to the head of the brick. Figure 2 shows the “as-installed” brick and joint. I call this a “clip-joint” where only the outer $\frac{1}{2}$ ” - $\frac{3}{4}$ ” or so of the brick receives mortar. The cosmetic appearance of the finished wall looks good. But there are hidden problems. When it comes time for the mason to run his jointing tool on the joint, instead of the compacting and densifying action that is supposed to be accomplished, the mortar in the clip-joint can actually be pushed back, breaking the initial bond that had formed between the brick and mortar....a perfect beginning for a leak. Remember, the function of mortar is to bond all of the bricks together for strength and water tightness.

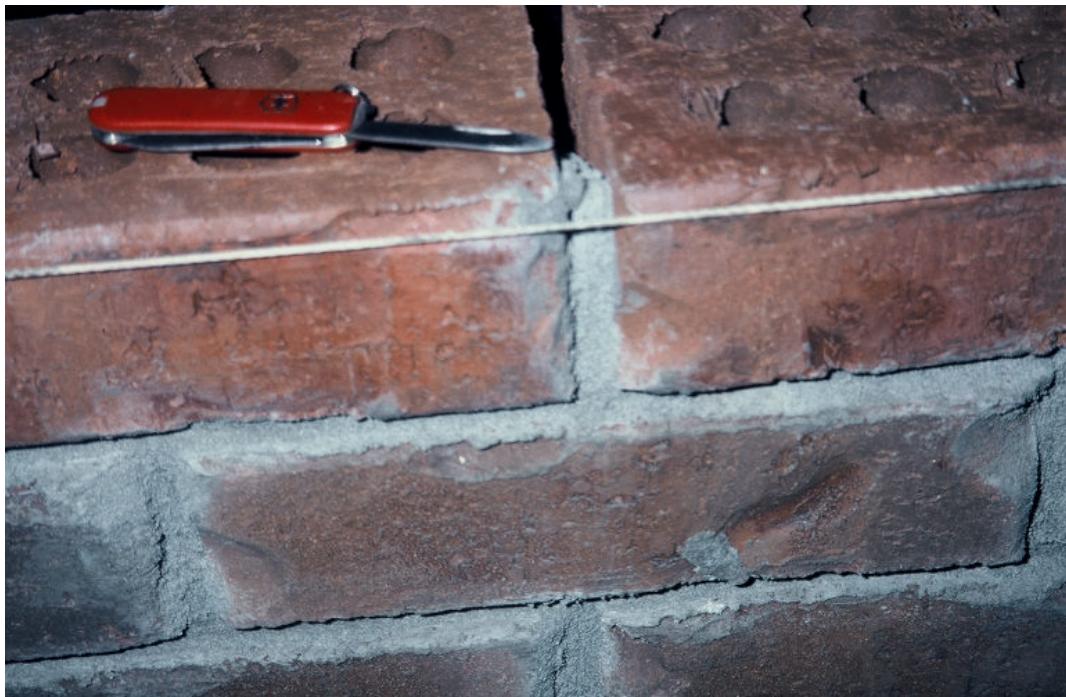
Figure 2. These joints look acceptable from the outside, but it is a typical “clip-joint” or non-full mortar head joint. A potential leakage area.

Head Joints for brick walls: These joints seem to be more susceptible to water leakage than bed joints. Needless to say, if they are not filled full, (full head joint) there will be mortar void areas which provide channels for water to run to the inside face of the wall / building.

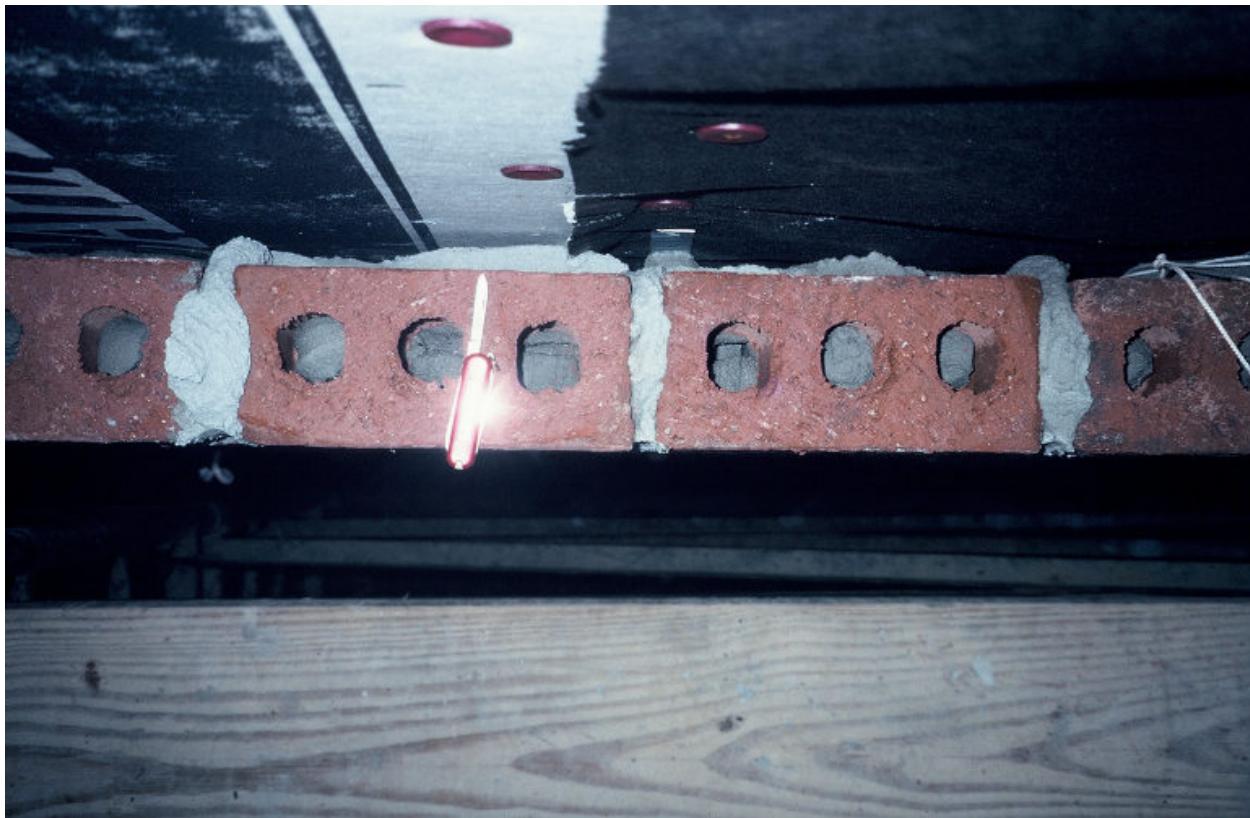
Figure 3. full head and bed joints

Bed joints for brick walls: these joints must be spread uniformly thick. Furrowing must be kept to a minimum, if performed at all, as some building codes prohibit furrowing. As the bricks are put/shoved into place, their weight and the weight of the coursed above will help to compact the mortar and help promote a water resistant joint. These efforts will provide a “void free” joint, not allowing collection areas for water that could cause areas of freeze damage or embedment corrosion.

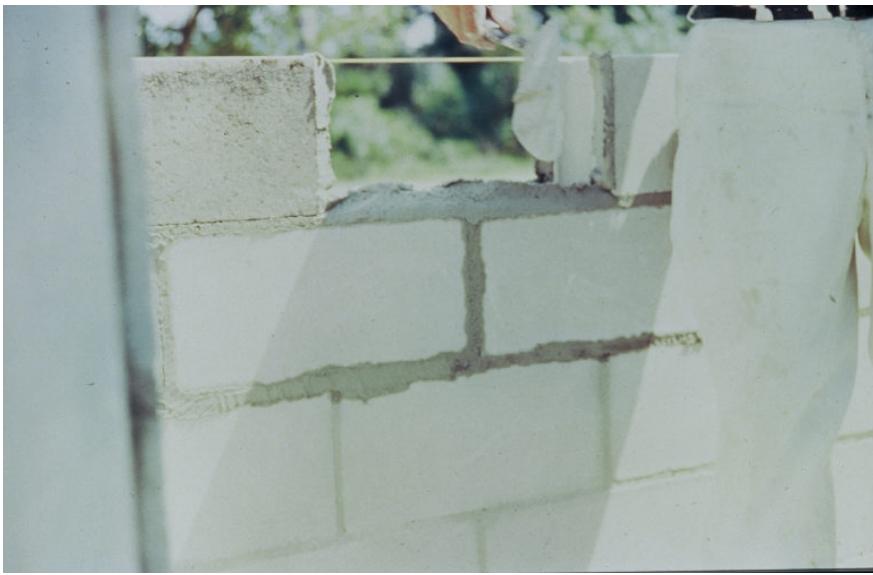
Figure 4: full bed and head joints at wall closure.

Head joints for block: a full width of mortar is applied to the ends of the face shell. Some masons apply the mortar to the ends already in place while others stand the block vertically and apply the mortar to the end. Regardless of the procedure, a full width of mortar is required.
