## TECHNICAL TOPIC:

# Concrete Blow-Up

### **BOTTOMLINE:**

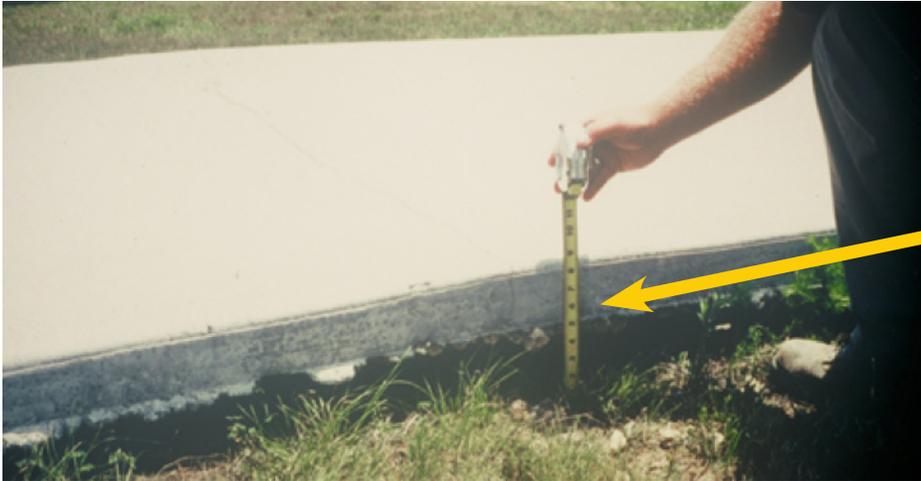
Figure 1. This slab has "blown up" about 5"

Figure 2. The long, thin, ribboned driveway is where the blow-up from Figure 1 above occurred. The actual location was about mid length in the driveway.

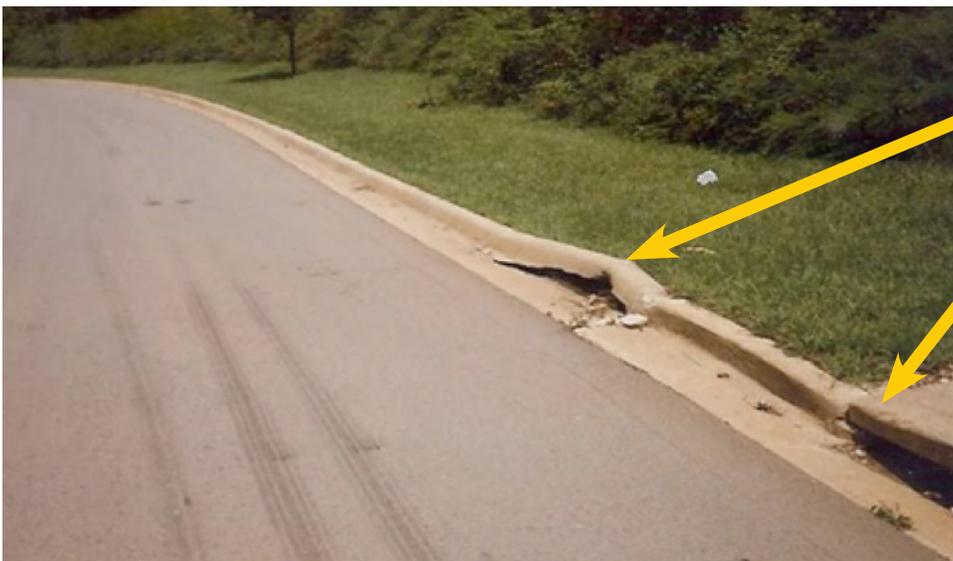
Figure 3. Blow-ups can also occur in curbing.

On this project, the catch basin in the lower right of the photo acted as an "anchor" or immovable feature... not allowing for expansion. Of course, the several hundred feet of curbing with inadequate jointing was a contributor as well.

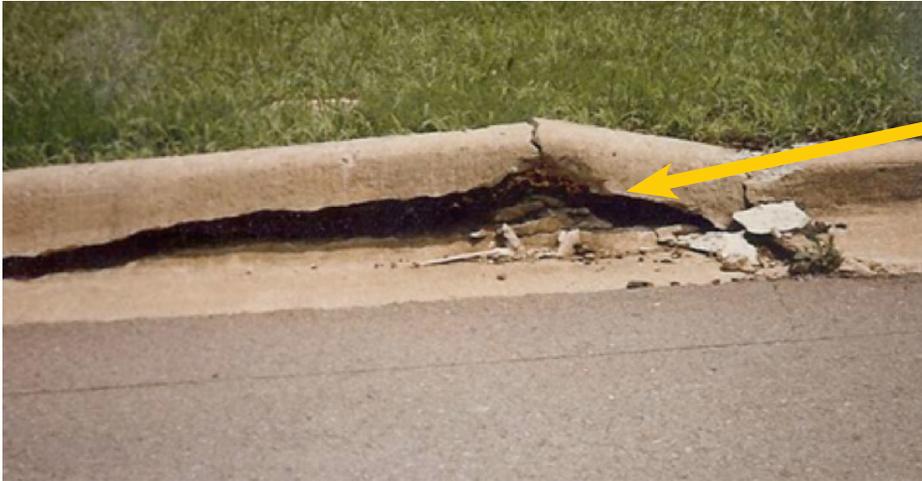
Curbing from figure 3

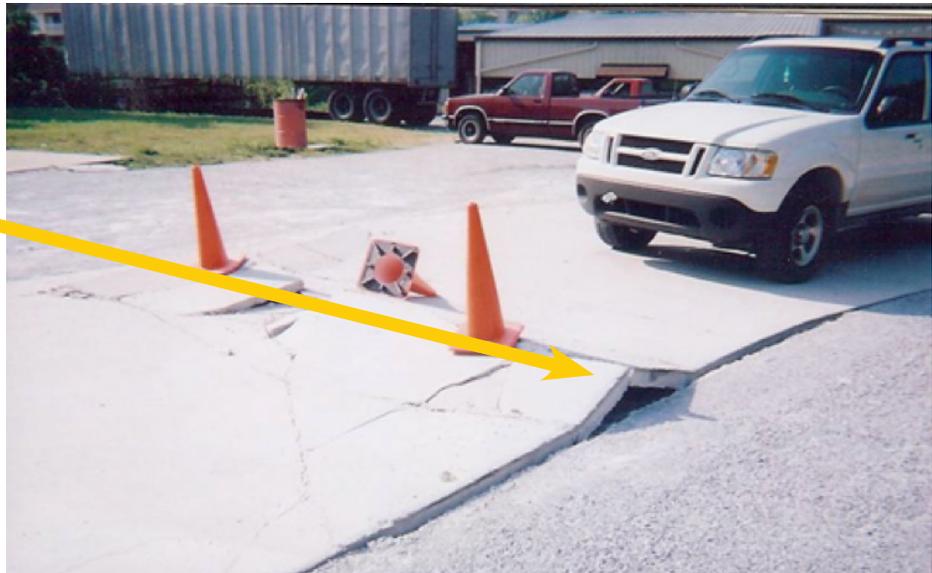
Figure 5.  
Severe blow-up.

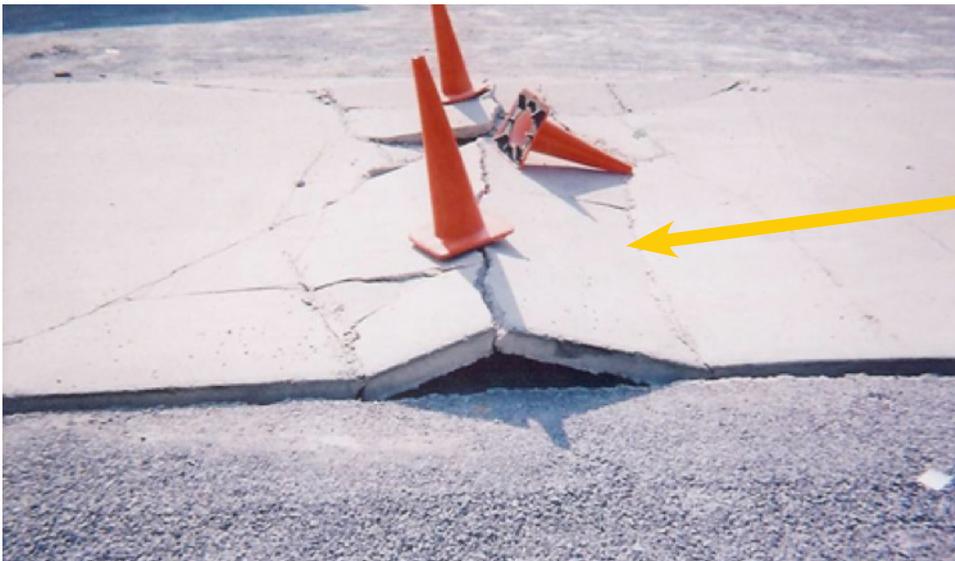
Figure 6: Blow-up from figure 5 above.  
Also known as "buckling" and "tenting".
